Technical Bulletin

Date Released:	12-11-2015	Tracking Number:	TBACE2-002
Document Revision:	REV A		
Date Revised:		Written By:	Brian Woods
Model/Part No.:	ACM135 / ACM150

Re: E2 code on thermostat with new installation

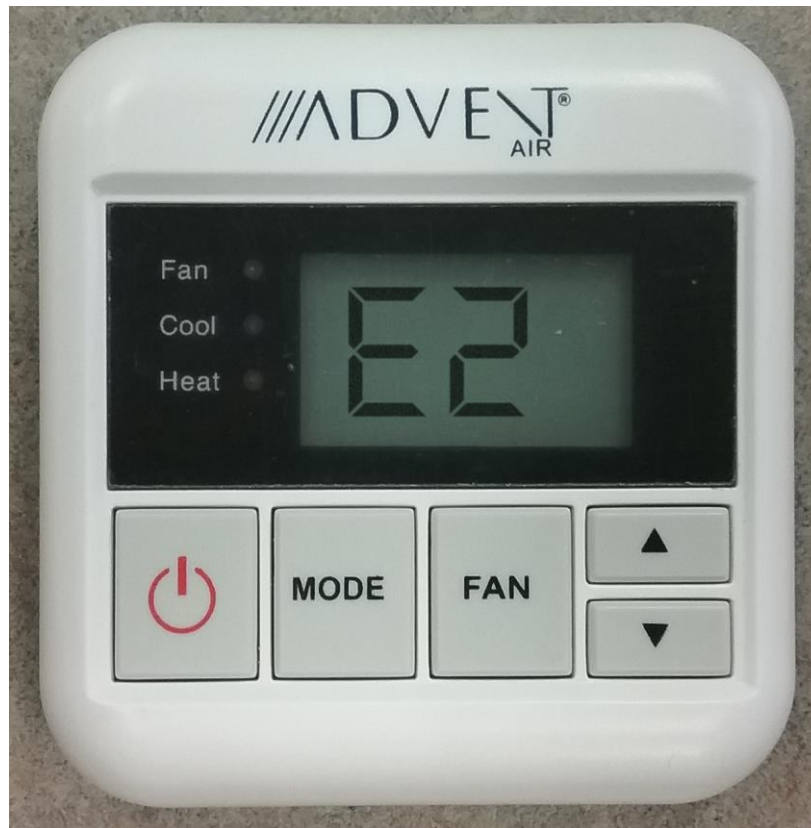
Details: Our ACM135 / ACM150 require 8 wires between the thermostat and the upper unit. Some aftermarket installations may have fewer wires than this requirement and additional wires must be run. Some dealers, upon initial installation, may see “E2” displayed on the thermostat.

This can occur in the following situations:

- Freeze Control is not connected between the relay kit and the sensor.
- The PURPLE wire is disconnected between the relay kit and the thermostat.

Note: All 8 wires must be used between the thermostat and the upper unit for correct operation.
